USAAVSCOM TR 92-D-2

ORGANIC MATRIX COMPOSITE HELICOPTER INTERNAL/ EXTERNAL CARGO PALLET SYSTEM (OMC INTEX)

Goldsworthy Engineering
Division of Alcoa Composites
1180 N. Mountain Springs Parkway
Springville, UT 84663-0910

Final Report for Period July 1986 - June 1990

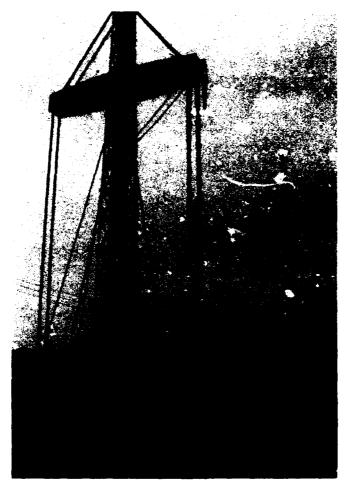
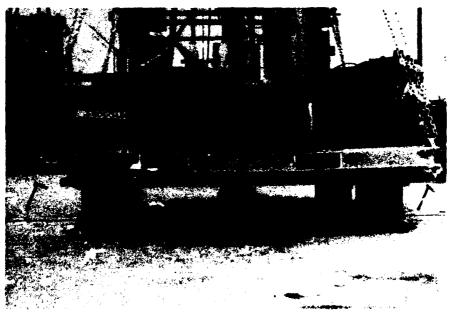
Figure 37. Hoist test, experimental pallet, 32,000-lb load.

Results: Both pallets failed criterion of success.

Pallet 002 failed on the first lift. Two adjacent corners pulled out.

Both experimental pallets met the criteria of success in all tests with the exception of the hoist test. Both pallets failed in the hoist test at the 32,000-lb load level. Table 8 summarizes the experimental pallet test results.

The hoist test failure mode for both pallets was the same: failure of the corners where tunnels are closest to the corners (Figure 38). This failure was viewed to be the result of a localized problem: i.e., poor integration of the corner with the tunnel opening reinforcement. Although the composite INTEX pallets were designed to carry a maximum weight of 10,000 lb, loads significantly greater than this can be experienced due to sudden acceleration during helicopter slinging. In this mode of loading, an amplification by a factor of 5.4, or 54,000 lb, is possible. Slinging lines are attached at lifting lugs at the pallet corners; they are not vertical, but are oriented inward at about 23°. Thus, nominally each corner of the pallet must carry an inward directed load of 14,670 lb. This load must be carried by the lifting lug, then the clevis, the corner reinforcement plate, and finally the edge members, which include the tunnel openings. In the tests, the load transition at the 32,000-lb level was successfully handled up to the point of transitioning the load into the tunnel openings closest to the corner. First, the aluminum tunnel opening reinforcement

de-bonded and then the lower corner of the tunnel opening failed in shear. Failure rapidly propagated from this point along the edge member and to the corner. Once failure was initiated, loads along this edge reduced and loads on the second edge increased, thus inducing failure at the tunnel openings on the second edge.

Since the failure was localized, the problem was believed to be solvable. The structural solution involved both the design of the tunnel opening reinforcement and the transition from the corner to the closest tunnel opening. A redesign program was initiated.
